RESERVE ANALYSIS REPORT

The Lofts at Westinghouse Condominiums

Hyde Park, Massachusetts

March 10, 2017

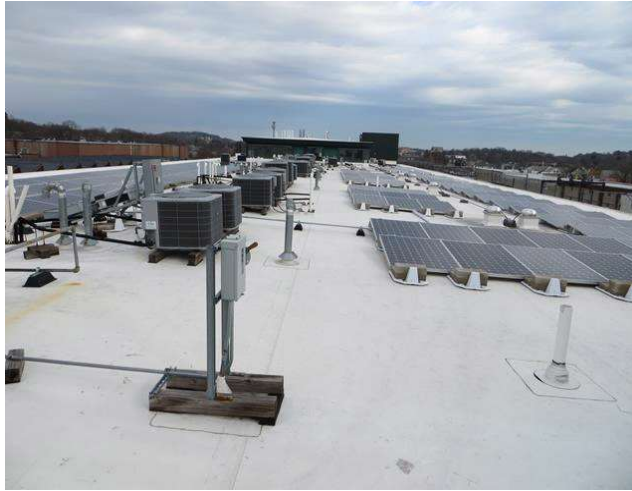
Roofing quantity 44,000 sq. ft. from Firestone Certificate of Warranty
Warranty was transferred to association on December 15, 2014.

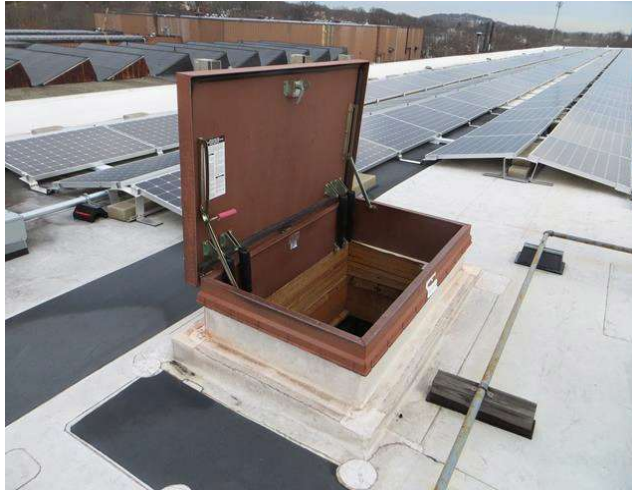
Category	010 Roof	Quantity	1 total
Photo Date	January 2017	Unit Cost	\$6,490.000
		% of Replacement	100.00%
		Current Cost	\$6,490.00
		Future Cost	\$9,087.57
Placed In Service	01/09		
Useful Life	25		
		Assigned Reserves at FYB	\$0.00
Remaining Life	17	Monthly Member Contribution	\$17.57
Replacement Year	2034	Monthly Interest Contribution	\$0.04
		Total Monthly Contribution	\$17.61

Pricing basis:

(2) Bilco Type S50 TB hatch \$1090 incl shipping

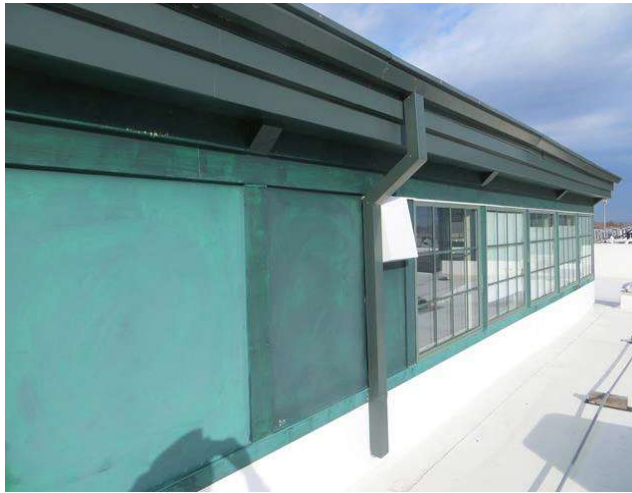
Gutters: 200'
Downspouts: 40'
Total: 240 linear ft

Replacement cost is \$40-\$50 per lin. ft.

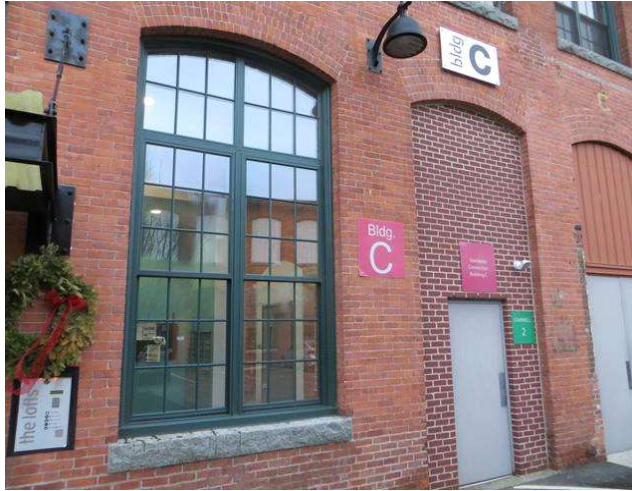
Building aluminum window units consist of (2) double hung windows mulled together with fixed archtop transom above. Total window area is about 60 sq. ft. per combination on floors 2 and 3. Total window area is about 80 sq. ft. per combination on 1st floor.

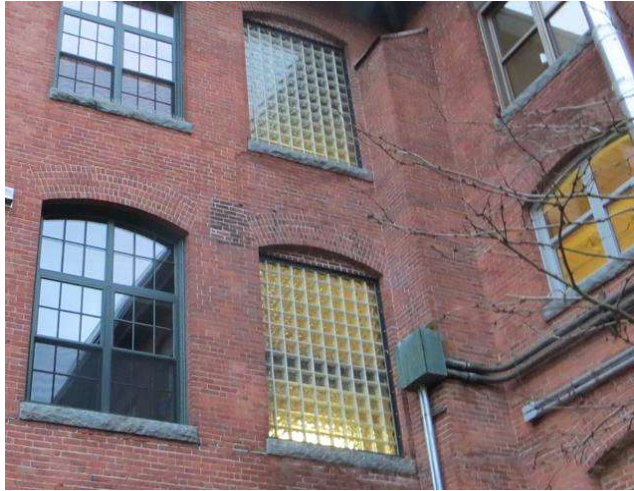
Installation date for glass block window is uncertain.
 FannieMae estimated useful life tables indicate 40 years.
 Maintaining mortar between glass block units will be critical to life span.

There are (2) glass block windows in each of the (3) stairwells.
 The bottom window in the north stairwell is truncated due to adjacent Building K.
 Each window is about 60 sq. ft.

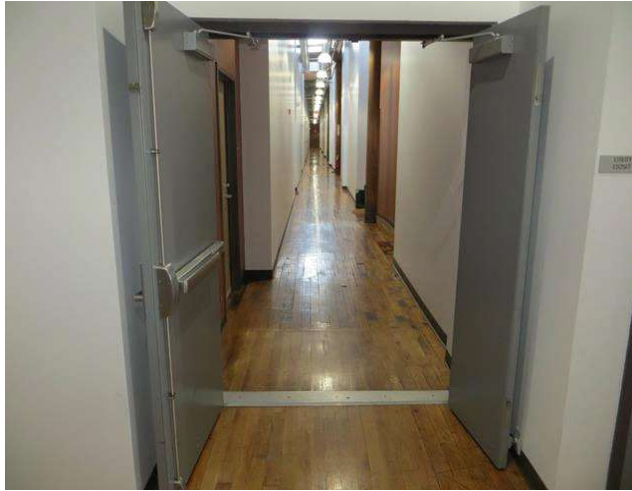
Category	030 Doors	Quantity	1 door group
Photo Date	January 2017	Unit Cost	\$50,870.000
		% of Replacement	100.00%
		Current Cost	\$50,870.00
Placed In Service	01/10	Future Cost	\$80,216.87
Useful Life	30		
		Assigned Reserves at FYB	\$0.00
Remaining Life	23	Monthly Member Contribution	\$93.04
Replacement Year	2040	Monthly Interest Contribution	\$0.22
		Total Monthly Contribution	\$93.26

All doors with the exception of double door from lobby hallway and bottom stairwell doors are interior doors.

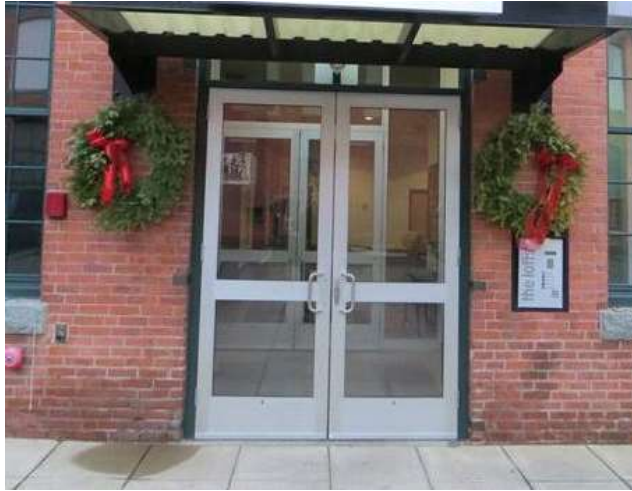
Aluminum frame entry door unit is a 6' wide double door measuring 74" x 96".

Building entry has two sets of doors. Outside doors are protected under overhang. Inside doors form vestibule to lobby and are not subject to weather.

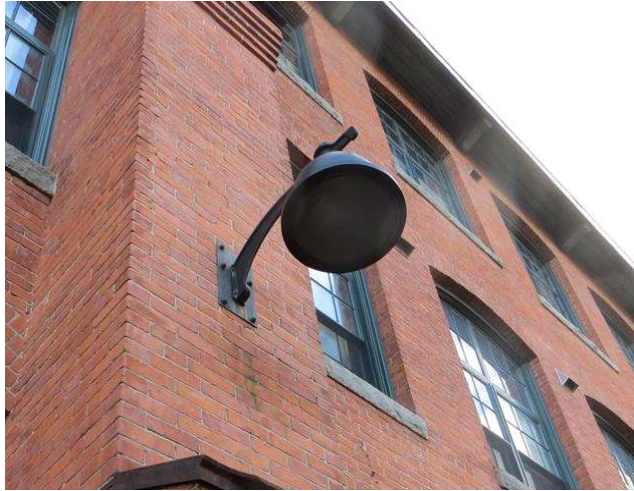
Category	040 Lighting	Quantity	1 total
Photo Date	January 2017	Unit Cost	\$9,400.000
		% of Replacement	100.00%
		Current Cost	\$9,400.00
Placed In Service	01/10	Future Cost	\$12,159.90
Useful Life	20		
		Assigned Reserves at FYB	\$3,290.00
Remaining Life	13	Monthly Member Contribution	\$25.21
Replacement Year	2030	Monthly Interest Contribution	\$0.97
		Total Monthly Contribution	\$26.18

Large canopy lights:

Fixture \$500

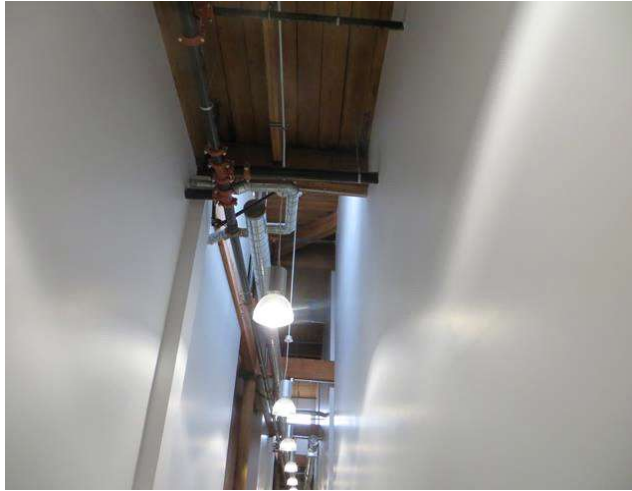
Category	040 Lighting	Quantity	1 total
Photo Date	January 2017	Unit Cost	\$37,150.000
		% of Replacement	100.00%
		Current Cost	\$37,150.00
Placed In Service	01/16	Future Cost	\$54,120.54
Useful Life	20		
		Assigned Reserves at FYB	\$0.00
Remaining Life	19	Monthly Member Contribution	\$87.40
Replacement Year	2036	Monthly Interest Contribution	\$0.20
		Total Monthly Contribution	\$87.60

1st floor lobby/entry:
 (12) 6" recessed lights
 (24) track lights
 (3) motion sensors to control lighting

2nd floor hallway:
 (45) 6" recessed lights
 (9) motion sensors to control lighting
 (7) dual head emergency lights

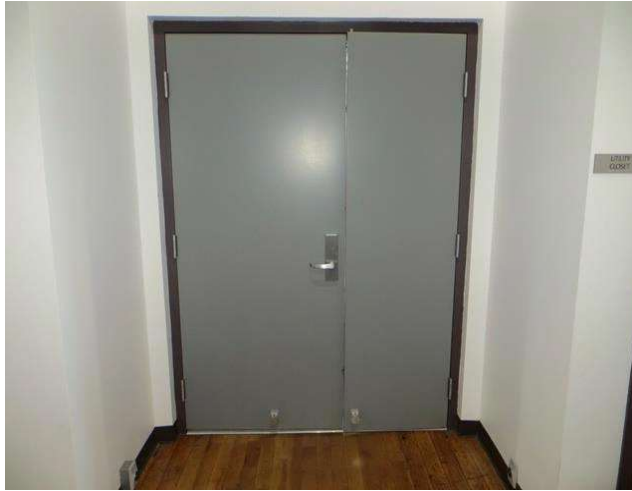
Steel and wood doors in hallways, stairwells, and miscellaneous common areas.
Steel doors painted. Wood doors clear polyurethane.

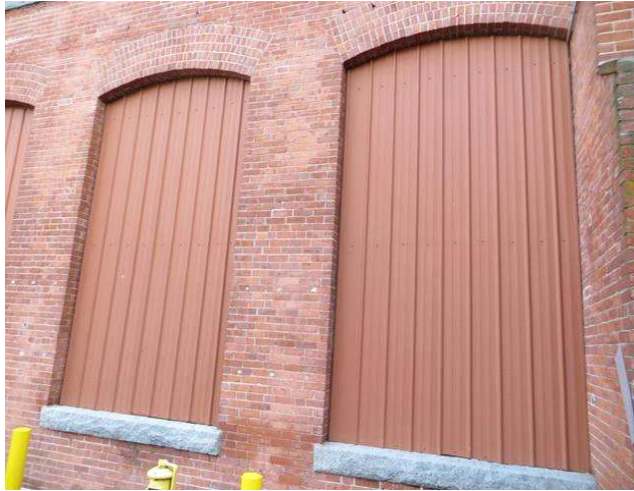
Category	050 Painting	Quantity	1 total
Photo Date	January 2017	Unit Cost	\$12,460.000
		% of Replacement	100.00%
		Current Cost	\$12,460.00
		Future Cost	\$14,312.62
Placed In Service	01/10		
Useful Life	10		
Adjustment	+4	Assigned Reserves at FYB	\$6,230.00
Remaining Life	7	Monthly Member Contribution	\$51.75
Replacement Year	2024	Monthly Interest Contribution	\$1.86
		Total Monthly Contribution	\$53.60

Sheet steel infill in former window locations:

Includes exterior door painted surfaces.

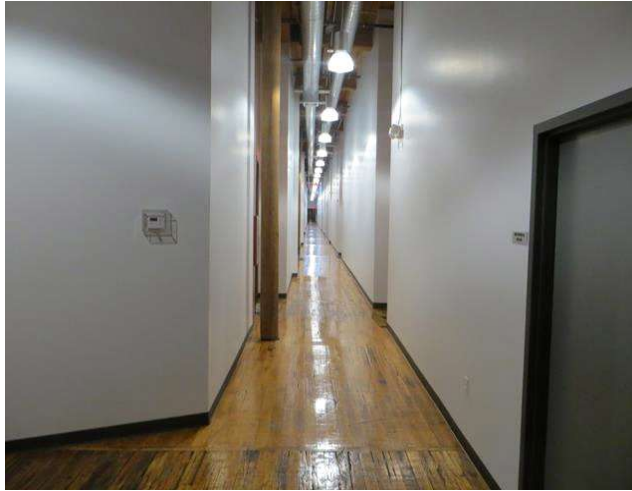
Category	050 Painting	Quantity	1 total
Photo Date	January 2017	Unit Cost	\$43,030.000
		% of Replacement	100.00%
		Current Cost	\$43,030.00
		Future Cost	\$55,663.89
Placed In Service	01/10		
Useful Life	20		
		Assigned Reserves at FYB	\$0.00
Remaining Life	13	Monthly Member Contribution	\$160.99
Replacement Year	2030	Monthly Interest Contribution	\$0.37
		Total Monthly Contribution	\$161.36

Wall areas:

1st floor: Lobby, vestibule, hallway, bathrooms: 4300 sq. ft.
 2nd floor: Hallway areas, trash room, gym, laundry, cleanup rooms, bathroom: 14,710 sq. ft.
 3rd floor: Hallway areas, trash room, gym: 22,510 sq. ft.
 Stairwell areas: 500 sq. ft.
 Total wall area: 42,000 sq. ft.

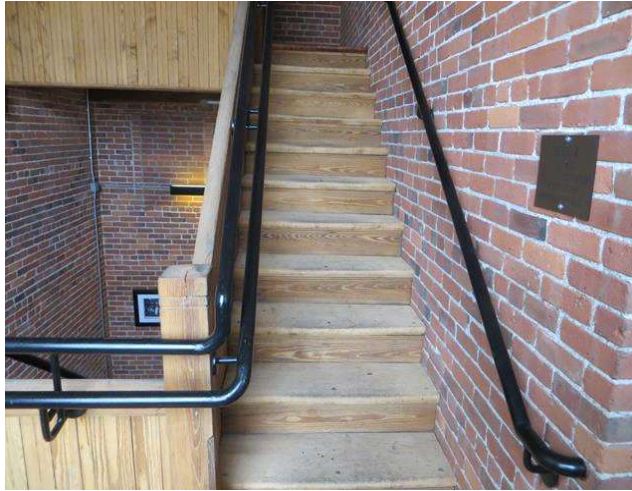
Main/Center #2 stairwell had best finished appearance. Treads, 1/2 walls, and ceilings are clear wood with minimal finish. Cast iron tread covers will wear indefinitely. Decision may be made to let current finish age without further attention. Brick in stairwell will only need periodic cleaning.

North #1 stairwell has intermediate finished appearance. Treads, 1/2 walls, and ceilings are clear wood with minimal finish. Decision may be made to let current finish age without further attention. Brick in stairwell will only need periodic cleaning.

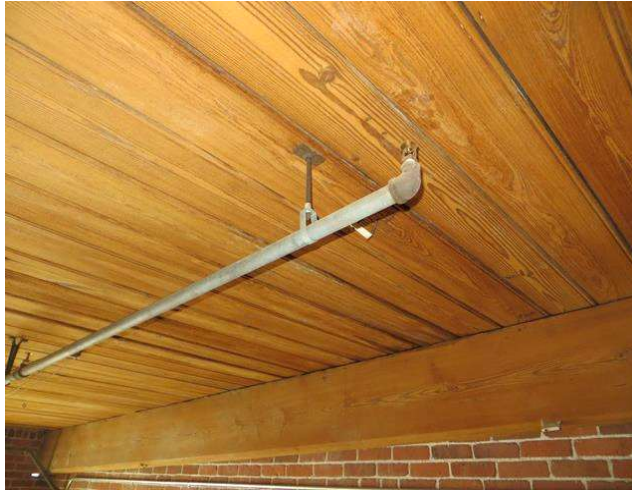
Ceilings will need occasional cleaning and periodic clear polyurethane finish.

3rd floor hallway areas, trash room, and gym have wood ceiling.
Include (14) wood support posts.

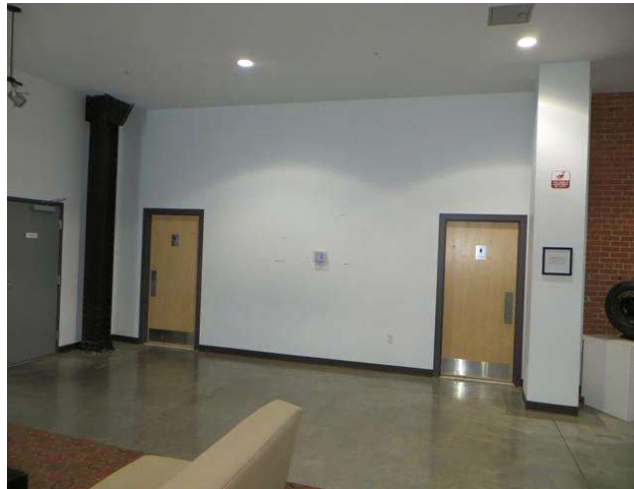
1st floor lobby/entry area is polished concrete.
Total area: 2010 sq. ft.

Polished concrete is a very long-lived material that needs periodic maintenance. If maintained properly, it will have a 99 year service life.

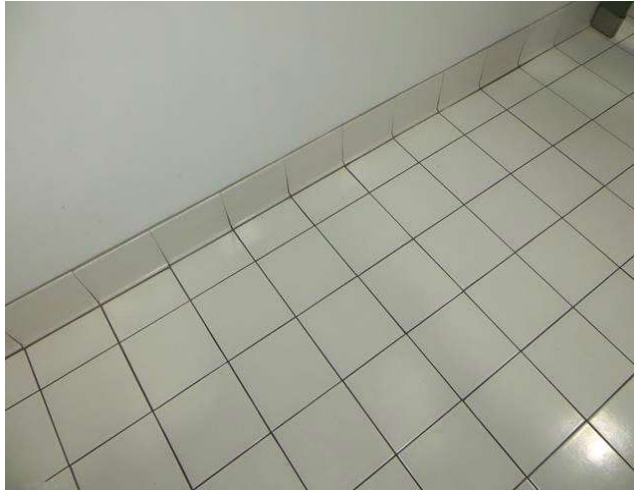
Category	060 Building Interior	Quantity	631 sq. ft.
Photo Date	January 2017	Unit Cost	\$20.000
		% of Replacement	100.00%
		Current Cost	\$12,620.00
Placed In Service	01/10	Future Cost	\$19,900.47
Useful Life	30		
		Assigned Reserves at FYB	\$0.00
Remaining Life	23	Monthly Member Contribution	\$23.08
Replacement Year	2040	Monthly Interest Contribution	\$0.06
		Total Monthly Contribution	\$23.14

1st floor bathrooms:
160 sq. ft per bathroom
Include wall tile 68 sq. ft. per bathroom

Stairwell areas:
Stair #1 (north) first floor entry area 175 sq. ft.

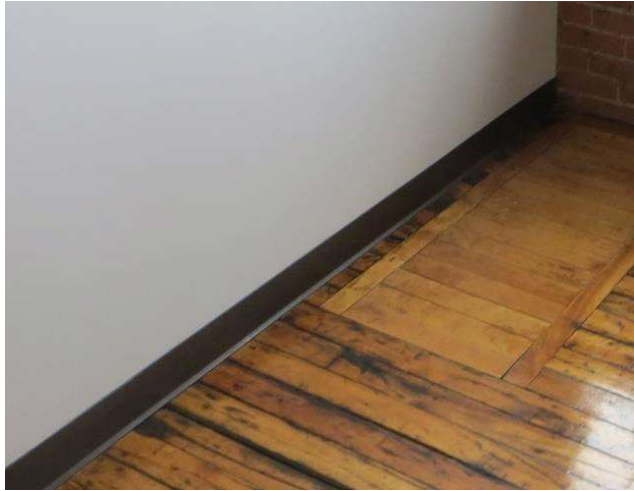
For more rustic building, assumed greater tolerance for floor defects before need to be refinished. Increased typical refinishing interval to 15 years.
When floor is refinished, vinyl baseboard may need replacement depending on level of care taken by flooring contractor.

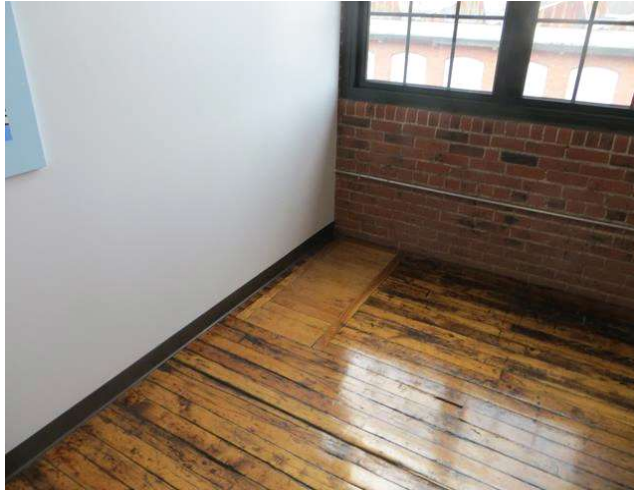
For rustic building, assumed greater tolerance for floor defects before need to be refinished. Increased typical refinishing interval to 15 years. Spot finishing higher traffic areas may extend this interval.

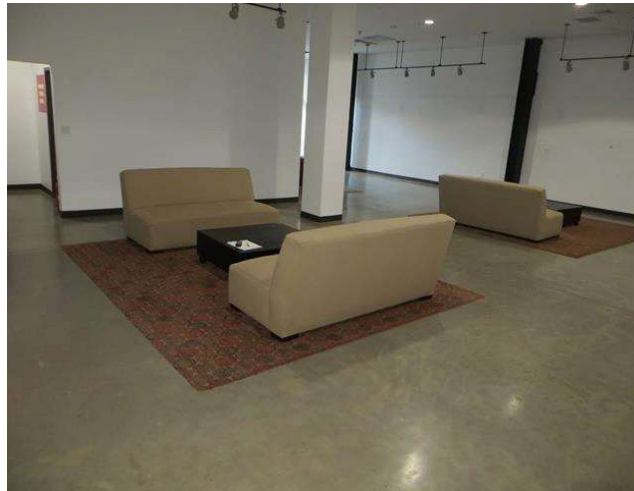
Category	060 Building Interior	Quantity	1 total
Photo Date	January 2017	Unit Cost	\$5,000.000
		% of Replacement	100.00%
		Current Cost	\$5,000.00
		Future Cost	\$5,306.04
Placed In Service	01/10		
Useful Life	10		
		Assigned Reserves at FYB	\$3,500.00
Remaining Life	3	Monthly Member Contribution	\$30.54
Replacement Year	2020	Monthly Interest Contribution	\$1.05
		Total Monthly Contribution	\$31.58

1st floor lobby/entry:
 (2) upholstered chairs
 (3) upholstered couches 72"
 (2) low coffee tables 40" x 40"
 (1) table large 36" x 72"
 (1) table small 16" x 48"
 (2) lamps
 (2) 10' x 12' area rug
 (1) 8' x 10' area rug
 (2) furniture carts

Electrical room off lobby:
 (31) stacked chairs
 (2) upholstered chairs

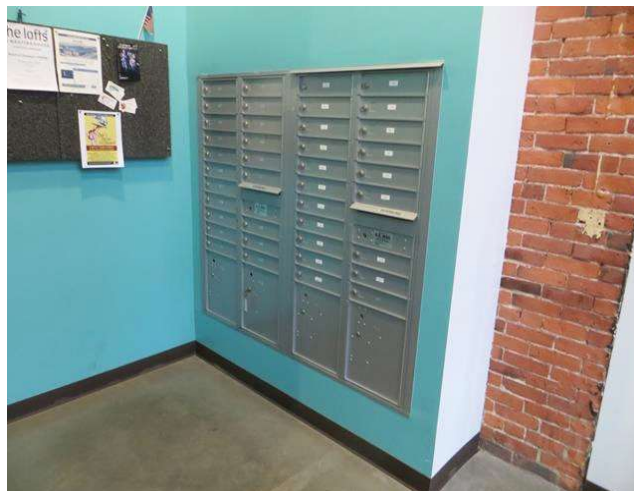
Category	060 Building Interior	Quantity	4 mailbox units
Photo Date	January 2017	Unit Cost	\$1,750.000
		% of Replacement	100.00%
		Current Cost	\$7,000.00
		Future Cost	\$11,038.29
Placed In Service	01/10		
Useful Life	30		
		Assigned Reserves at FYB	\$0.00
Remaining Life	23	Monthly Member Contribution	\$12.80
Replacement Year	2040	Monthly Interest Contribution	\$0.03
		Total Monthly Contribution	\$12.83

(4) double column mailbox units with front access for USPS
Each mailbox unit is \$1500 delivered (globalindustrial.com), \$250 for installation

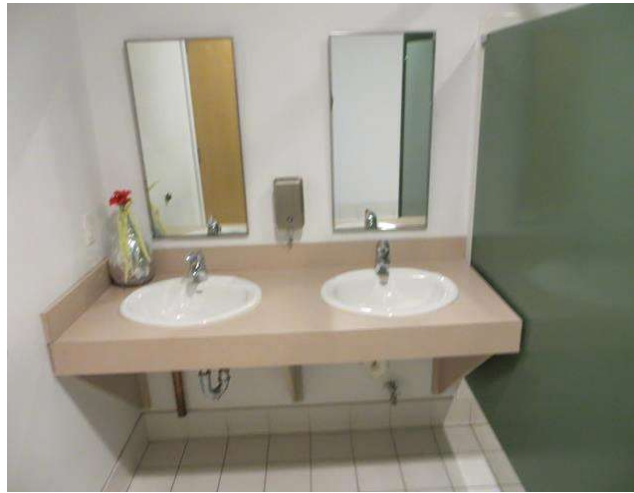
Category	060 Building Interior	Quantity	2 bathroom
Photo Date	January 2017	Unit Cost	\$10,000.000
		% of Replacement	100.00%
		Current Cost	\$20,000.00
Placed In Service	01/10	Future Cost	\$25,872.13
Useful Life	20		
		Assigned Reserves at FYB	\$3,590.00
Remaining Life	13	Monthly Member Contribution	\$63.96
Replacement Year	2030	Monthly Interest Contribution	\$1.14
		Total Monthly Contribution	\$65.10

Mens room:

- 60" x 24" laminate counter with back splash
- (2) oval porcelain sink
- (2) chrome single hole faucet
- Soap dispenser
- (2) Wall mirror
- (1) large stainless steel paper towel dispenser
- (2) white toilet with seat
- (2) toilet paper holders
- (1) white urinal
- (2) stall dividers, baked enamel
- (1) urinal divider, baked enamel

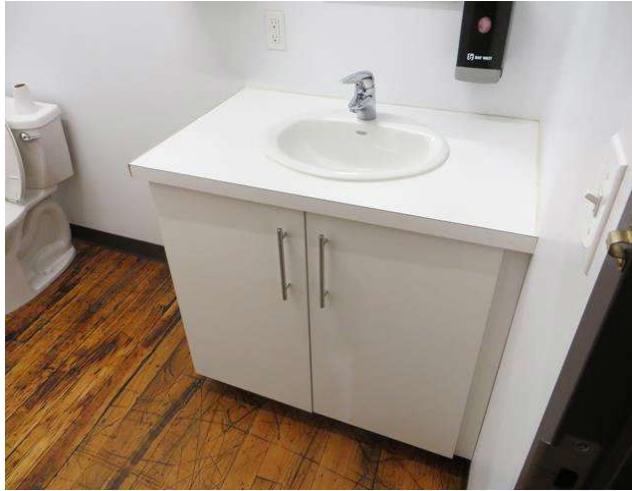
Category	060 Building Interior	Quantity	1 bathroom
Photo Date	January 2017	Unit Cost	\$4,000.000
		% of Replacement	100.00%
		Current Cost	\$4,000.00
Placed In Service	01/10	Future Cost	\$5,174.43
Useful Life	20		
		Assigned Reserves at FYB	\$1,400.00
Remaining Life	13	Monthly Member Contribution	\$10.73
Replacement Year	2030	Monthly Interest Contribution	\$0.42
		Total Monthly Contribution	\$11.15

2nd floor common bathroom:

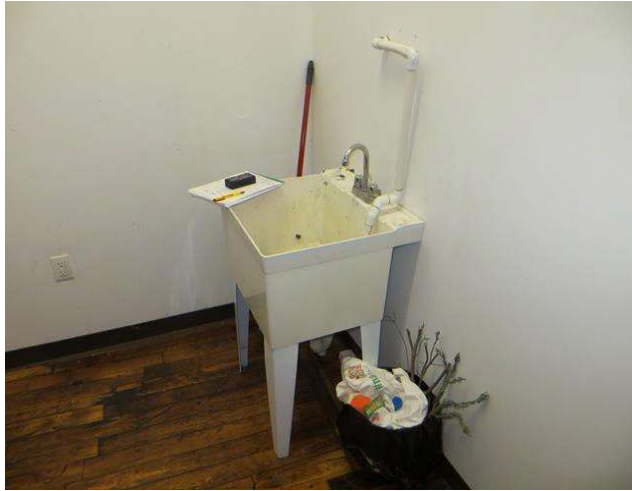
Category	070 Equipment	Quantity	3 sinks
Photo Date	January 2017	Unit Cost	\$300.000
		% of Replacement	100.00%
		Current Cost	\$900.00
Placed In Service	01/10	Future Cost	\$1,054.49
Useful Life	15		
		Assigned Reserves at FYB	\$420.00
Remaining Life	8	Monthly Member Contribution	\$3.44
Replacement Year	2025	Monthly Interest Contribution	\$0.12
		Total Monthly Contribution	\$3.57

North clean up room on second floor has one laundry sink.
South clean up room on second floor has two laundry sinks.

1	Mustee sink and faucet	@	\$150.00	=	\$150.00
1	labor to install	@	\$150.00	=	\$150.00
	TOTAL	=			<u>\$300.00</u>

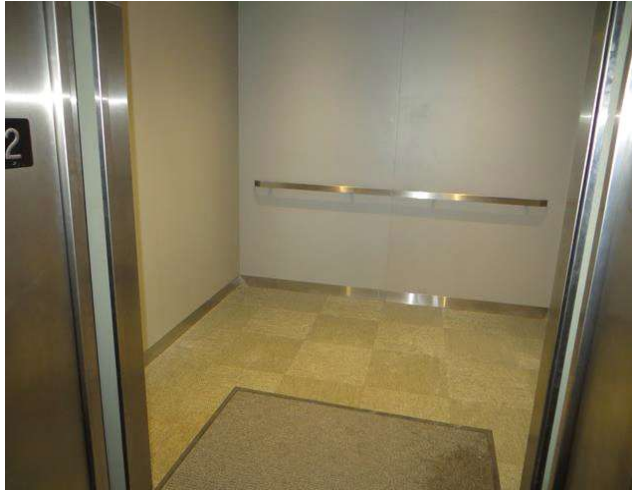
9' x 9' x 9' interior height elevator cab

This component is for basic refurbishment of elevator cab finishes. If elevator controls are included cost will be higher.

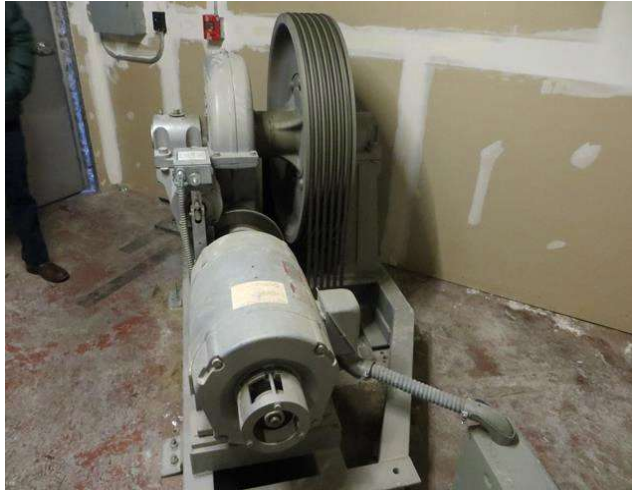
Single traction elevator serves 2nd and 3rd floor. No basement.

The elevator was installed with completely new equipment in 2010 for a total cost of \$112,000 per Mike Boyce of Commonwealth Elevator 617-593-4661. With 2% inflation, price increases to \$126,130 in 2016.

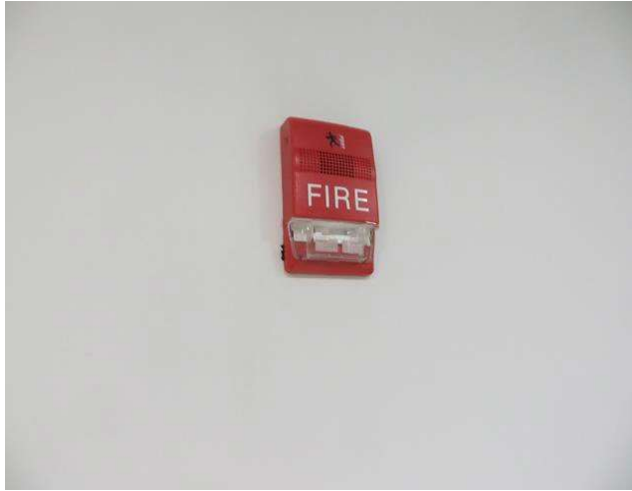
Category	070 Equipment	Quantity	1 total
Photo Date	January 2017	Unit Cost	\$16,450.00
		% of Replacement	100.00%
		Current Cost	\$16,450.00
Placed In Service	01/10	Future Cost	\$17,456.87
Useful Life	10		
		Assigned Reserves at FYB	\$11,515.00
Remaining Life	3	Monthly Member Contribution	\$100.47
Replacement Year	2020	Monthly Interest Contribution	\$3.44
		Total Monthly Contribution	\$103.91

Entrance lobby and restrooms:

- (4) fire alarm wall light
- (2) fire alarm pull station
- (6) smoke detector alarm

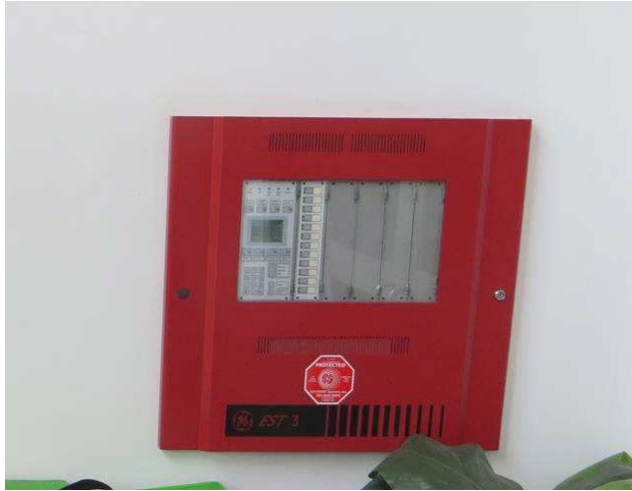
GE ES-3 main control panel
Main panels have useful life of 20 years
(5) fire alarm booster power supply

Fire alarm system is cleaned, inspected, and tested quarterly or annually as part of operating budget.
Out of date components or failed components are replaced at that time.

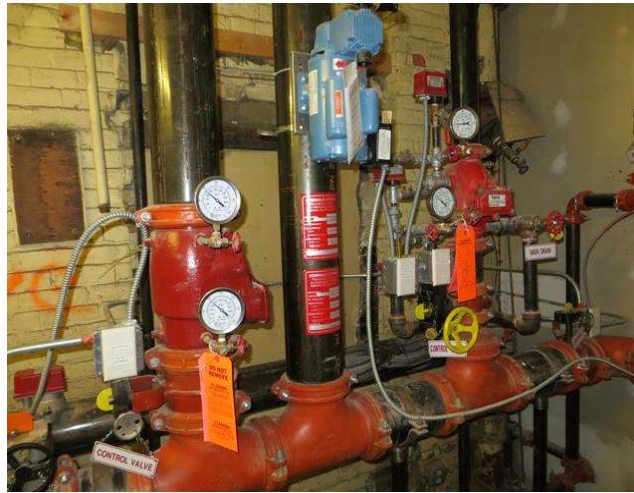
System is serviced by Clarion Fire Protection, Inc. 617-903-3191
Tom Kennedy 781-640-9116 stated that system will typically have a long life due to benign environment.
Sprinkler heads will have to be tested and replaced if needed after 50 years
Typical component cost to replace is \$1500 - \$2500.
Pressure gages were recently replaced after 5 years as required.
Repairs are typically done on an as needed basis.

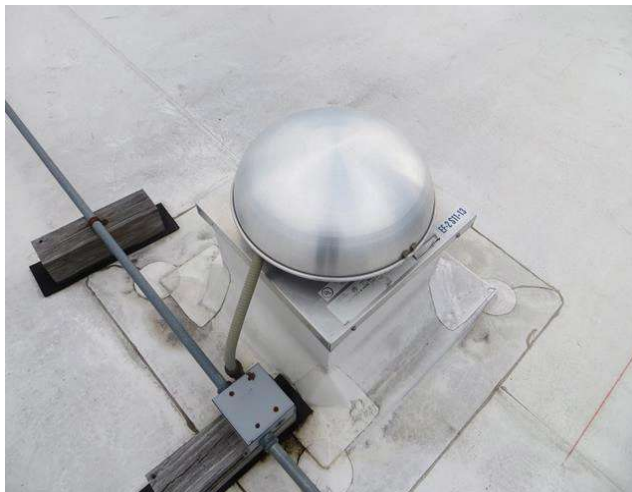
Category	070 Equipment	Quantity	11 fans
Photo Date	January 2017	Unit Cost	\$582.000
		% of Replacement	100.00%
		Current Cost	\$6,402.00
		Future Cost	\$7,500.96
Placed In Service	01/10	Assigned Reserves at FYB	\$2,987.60
Useful Life	15	Monthly Member Contribution	\$24.50
Remaining Life	8	Monthly Interest Contribution	\$0.89
Replacement Year	2025	Total Monthly Contribution	\$25.38

Soler and Palau LPD081AS ventilation fans
 \$382 material cost with delivery per Ferguson Enterprises
 Installation \$200 per John Guglielmi of G&G Mechanical

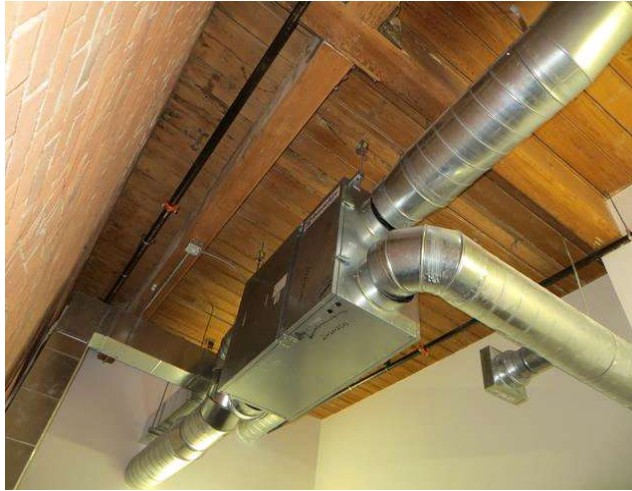
RenewAire energy recovery ventilation fans
 Model HE1X-INH
 Recover heat and humidity from exhaust air
 (4) units per John Guglielmi of G&G Mechanical
 \$5000 material cost per Renewaire representative

Installation: John Guglielmi estimates installation cost for (3) technicians for 1 day will be about \$1800.

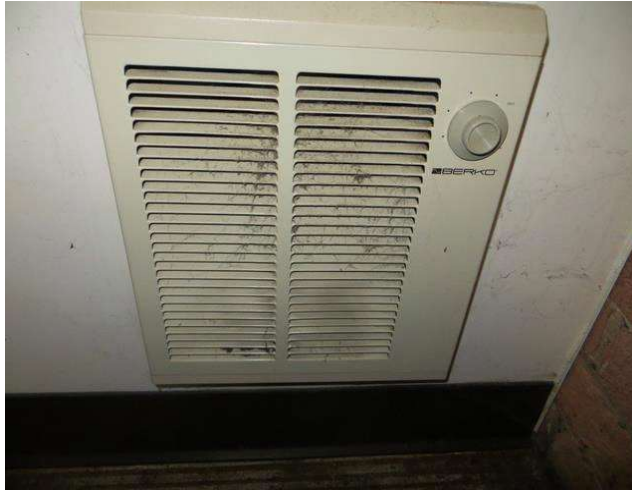
Category	070 Equipment	Quantity	1 total
Photo Date	January 2017	Unit Cost	\$6,350.00
		% of Replacement	100.00%
		Current Cost	\$6,350.00
Placed In Service	01/10	Future Cost	\$8,214.40
Useful Life	20		
		Assigned Reserves at FYB	\$2,222.50
Remaining Life	13	Monthly Member Contribution	\$17.03
Replacement Year	2030	Monthly Interest Contribution	\$0.66
		Total Monthly Contribution	\$17.69

Elevator control room mini-split heat pump:
Sanyo unit to control equipment room temperature
\$5000

Stairwell heaters:
Berko small room fan forced wall heater
\$250 material
\$200 installation

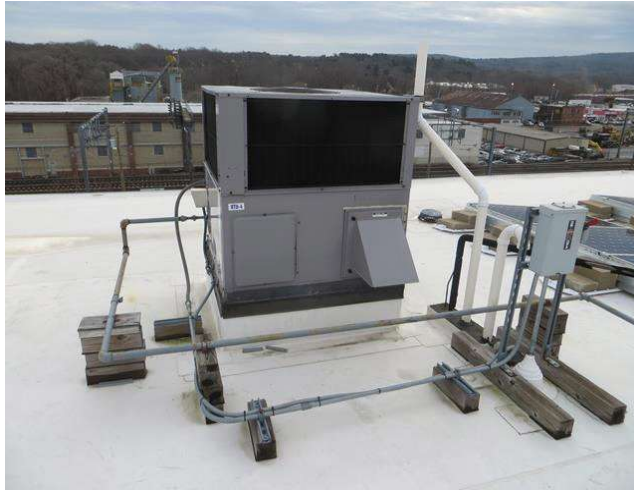
Packaged gas furnace/air conditioner system
With approximately 73,000 Btu furnace output and 3-1/2 tons cooling
Carrier model # 48vl-0422905

John Guglielmi of G&G Mechanical estimates cost to replace rooftop unit is \$8500 per unit including crane to lift and remove unit.

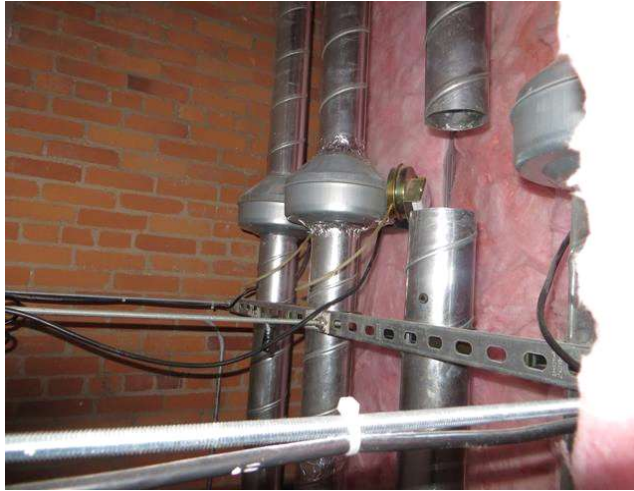
- (3) dryer exhaust duct booster fans are installed
- (4) ducts/dryer hookup positions are available

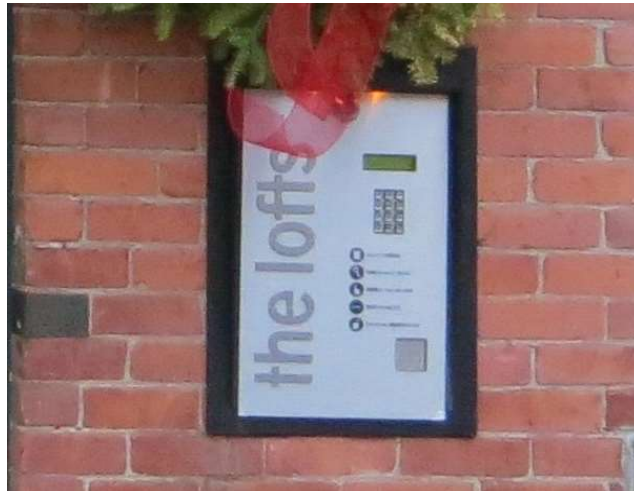
Category	070 Equipment	Quantity	1 access control
Photo Date	January 2017	Unit Cost	\$1,500.00
		% of Replacement	100.00%
		Current Cost	\$1,500.00
		Future Cost	\$1,940.41
Placed In Service	01/10		
Useful Life	20		
		Assigned Reserves at FYB	\$525.00
Remaining Life	13	Monthly Member Contribution	\$4.02
Replacement Year	2030	Monthly Interest Contribution	\$0.15
		Total Monthly Contribution	\$4.18

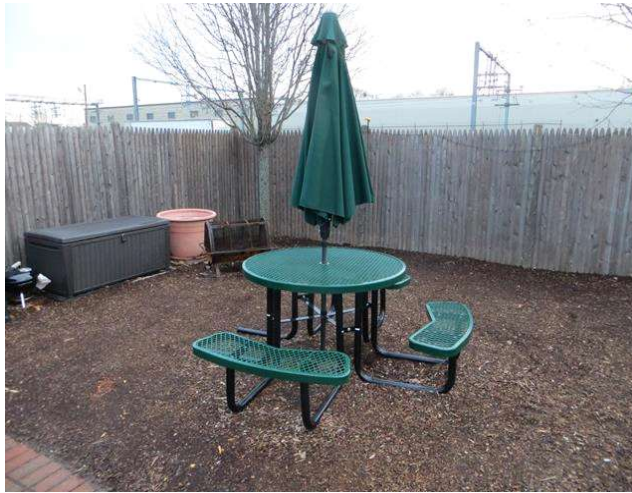
Category	070 Equipment	Quantity	1 total
Photo Date	January 2017	Unit Cost	\$4,100.000
		% of Replacement	100.00%
		Current Cost	\$4,100.00
		Future Cost	\$6,594.59
Placed In Service	01/16		
Useful Life	25		
		Assigned Reserves at FYB	\$0.00
Remaining Life	24	Monthly Member Contribution	\$7.07
Replacement Year	2041	Monthly Interest Contribution	\$0.02
		Total Monthly Contribution	\$7.09

2	plastic-coated table with benches	@	\$1,100.00	=	\$2,200.00
2	charcoal grills	@	\$550.00	=	\$1,100.00
1	painted wooden picnic table	@	\$250.00	=	\$250.00
1	painted wooden bench w/side planters	@	\$300.00	=	\$300.00
1	composite storage trunk	@	\$250.00	=	\$250.00
	TOTAL			=	<u>\$4,100.00</u>

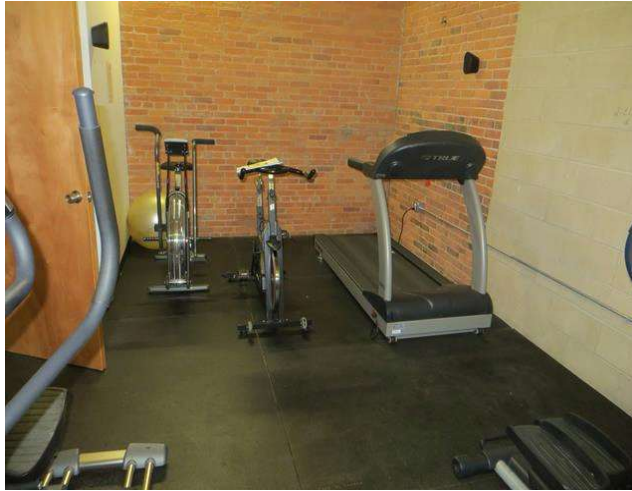
Category	070 Equipment	Quantity	1 total
Photo Date	January 2017	Unit Cost	\$5,000.000
		% of Replacement	100.00%
		Current Cost	\$5,000.00
		Future Cost	\$5,858.30
Placed In Service	01/10		
Useful Life	10		
Adjustment	+5	Assigned Reserves at FYB	\$2,333.33
Remaining Life	8	Monthly Member Contribution	\$19.13
Replacement Year	2025	Monthly Interest Contribution	\$0.70
		Total Monthly Contribution	\$19.83

Service life of gym equipment is heavily influenced by amount of use.
Equipment should be evaluated annually.

2nd floor gym:

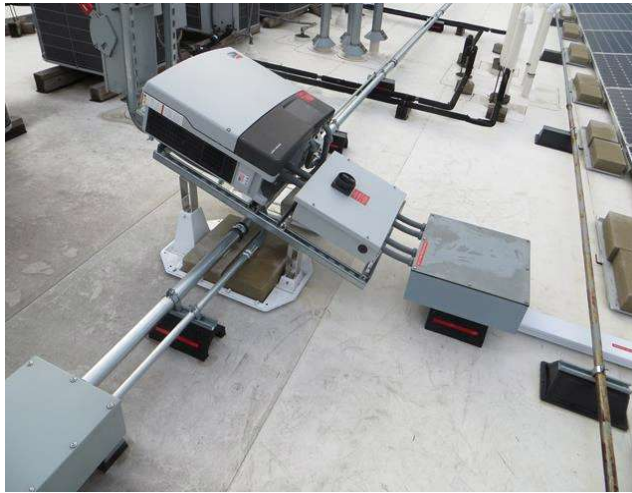
SMA America Sunny Tripower 24000TL-US central inverters
Very difficult to predict future cost due to evolving technology and declining cost.

Current inverter cost is 20-25 cents per watt (including shipping).
Single 24,000-watt inverter cost is about \$5,500.
\$750 installaton labor.
Per Richard Kane of Sunbug Solar.

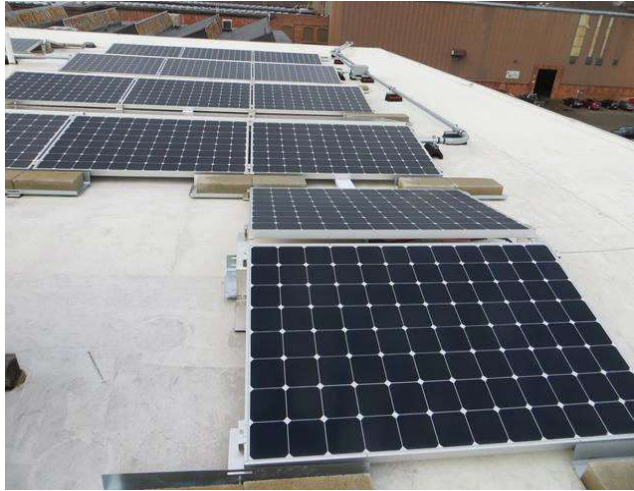
(648) Sunpower SPR-E20-327-COM panels

Very difficult to predict future cost due to evolving technology and cost declines.

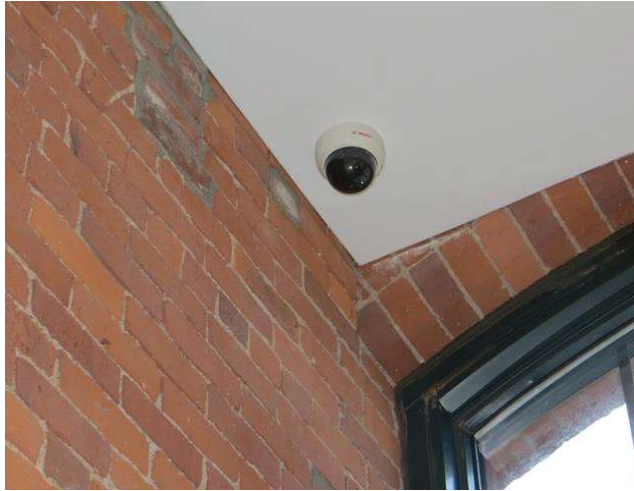
Category	070 Equipment	Quantity	7 cameras
Photo Date	January 2017	Unit Cost	\$1,500.000
		% of Replacement	100.00%
		Current Cost	\$10,500.00
Placed In Service	01/13	Future Cost	\$11,824.71
Useful Life	10		
		Assigned Reserves at FYB	\$4,200.00
Remaining Life	6	Monthly Member Contribution	\$59.23
Replacement Year	2023	Monthly Interest Contribution	\$1.30
		Total Monthly Contribution	\$60.53

Surveillance system control panel and associated equipment is a master condo association responsibility per property manager. Cameras within association building are responsibility of The Lofts at Westinghouse. Exact specifications for cameras is unknown. An average cost per camera is specified. Pricing can vary considerably.

Bosch camera locations:

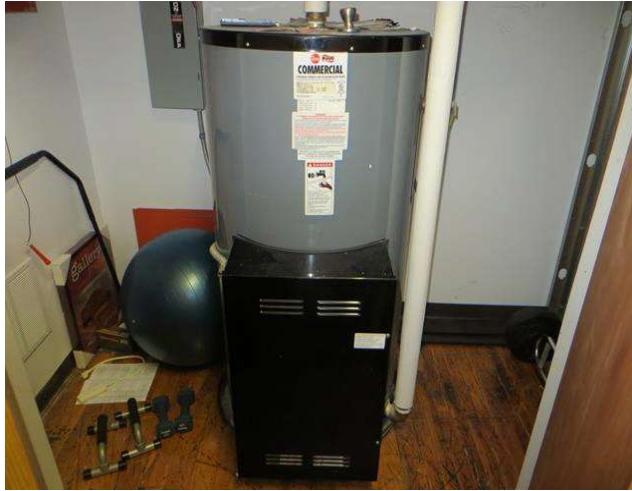
Category	070 Equipment	Quantity	1 total
Photo Date	January 2017	Unit Cost	\$2,750.00
		% of Replacement	100.00%
		Current Cost	\$2,750.00
Placed In Service	01/10	Future Cost	\$2,918.32
Useful Life	10		
		Assigned Reserves at FYB	\$1,925.00
Remaining Life	3	Monthly Member Contribution	\$16.80
Replacement Year	2020	Monthly Interest Contribution	\$0.57
		Total Monthly Contribution	\$17.37

South common cleanup room on second floor

(1) Ruud 85 gallon commercial electric water heater located in gym closet

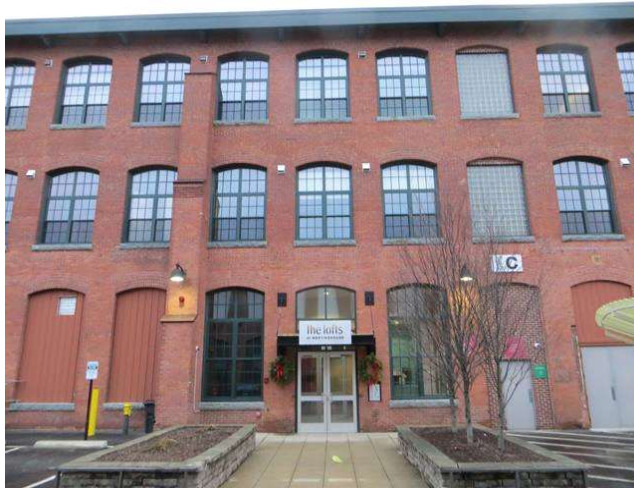
Building originally constructed in 1908.

Brick has experienced little need for repair in recent years per property manager and is in good condition per mason Ritchie O'Gryzek 508-962-0582.

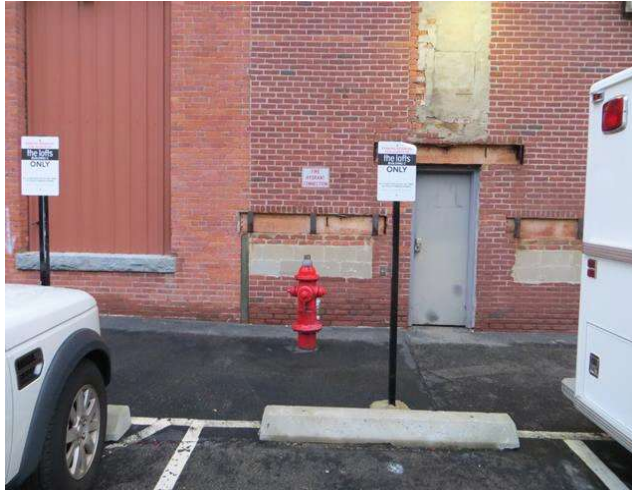
Brick has experienced little need for repair in recent years per property manager and is in good condition per mason Ritchie O'Gryzek 508-962-0582.

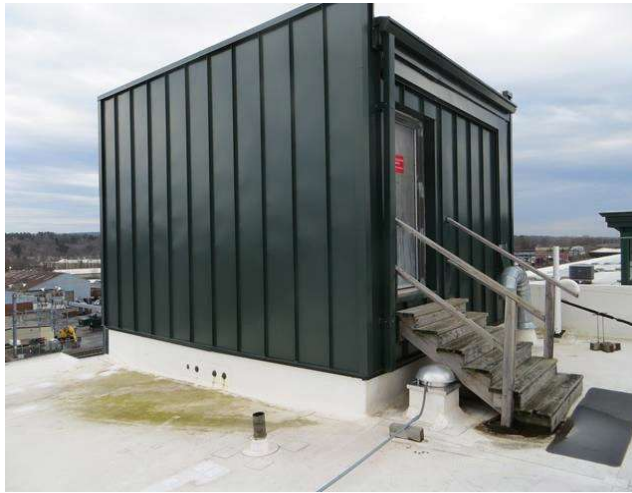
(2) elevator equipment/control rooms have perimeter of approximately 64' and wall height of 10' = 640 sq ft
New steel siding installed in 2016 by J&S Building Exteriors, Inc.

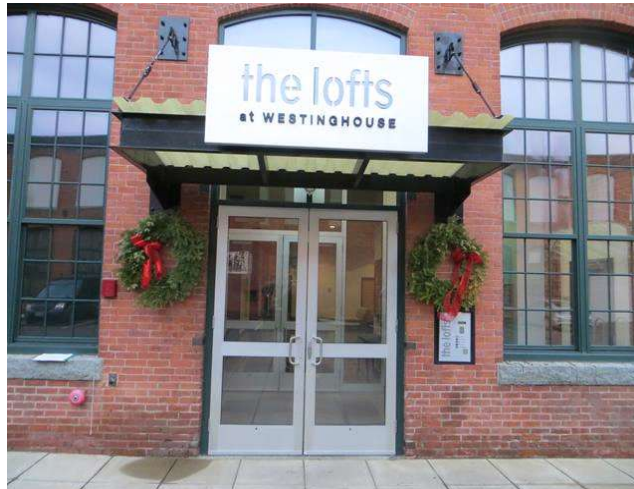
Category	080 Building Exterior	Quantity	1 total
Photo Date	January 2017	Unit Cost	\$3,500.000
		% of Replacement	100.00%
		Current Cost	\$3,500.00
		Future Cost	\$4,998.86
Placed In Service	01/10		
Useful Life	25		
		Assigned Reserves at FYB	\$0.00
Remaining Life	18	Monthly Member Contribution	\$8.82
Replacement Year	2035	Monthly Interest Contribution	\$0.02
		Total Monthly Contribution	\$8.84

Major sign Inventory:

Large condo association name sign at north corner \$2500
